**Environmental
Operations, Inc.**
CLEARING THE WAY

February 9, 2017

RE: Vapor Intrusion – Sub Slab Sampling Revised Report
Solutia – John F. Queeny Plant
St. Louis, Missouri
EPA ID No. MOD 004 954 111

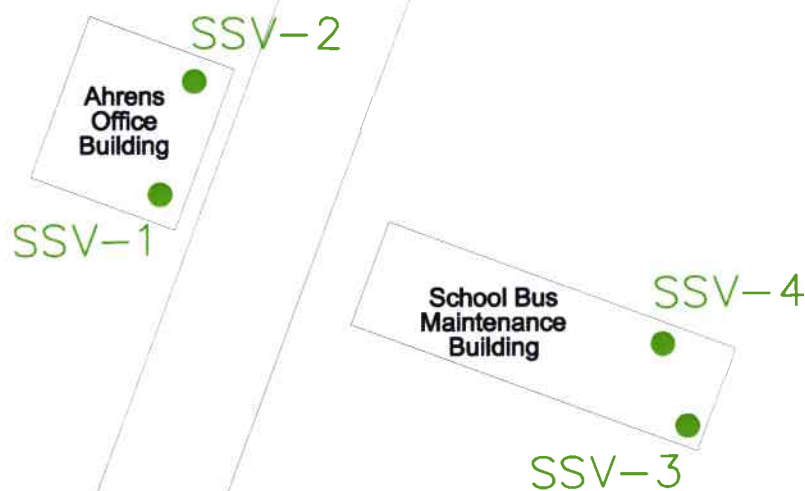
The general Solutia site location is depicted in Figure 1. Figure 2 shows the two buildings identified and described in the work plan for collecting the sub-slab samples. The figure also shows the approximate location of the samples and their designation. These buildings are on property owned by Ahrens Contracting, Inc. (Ahrens). Mr. Ted Ahrens, Jr. was contacted to facilitate access. To minimize any disruptions to regular work activities at the planned locations, at the request of Mr. Ahrens, we agreed to conduct the sub-slab vapor collection on Saturday, September 24, 2016.

**Sub-Slab Vapor
Sample Locations**
Former Solutia Queeny Plant
Saint Louis, Missouri
